GEBELEIN I THE SPEOS

DEPARTMENT OF EGYPTOLOGY – FACULTY OF ORIENTAL STUDIES and POLISH CENTRE OF MEDITERRANEAN ARCHAEOLOGY UNIVERSITY OF WARSAW

WARSAW 2020

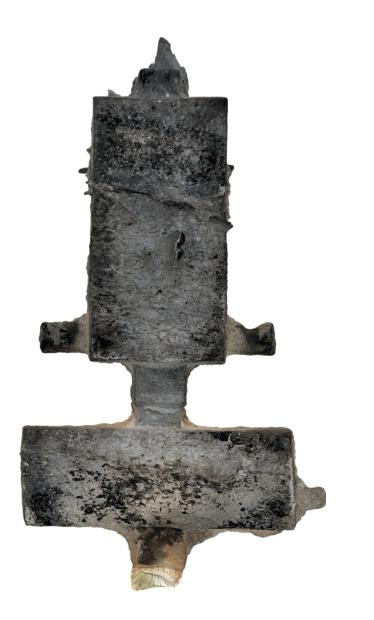
1. Photogrammetric ground plan of the speos.

2.1. Photogrammetric ground plan of the speos (P. Witkowski).

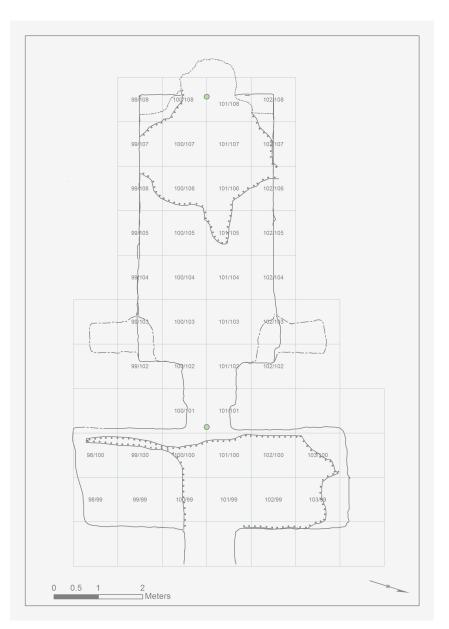
2. Ground plan of the speos showing the grid system and the outlines of intrusions.

2.2. Ground plan of the speos showing the grid system and the outlines of intrusions

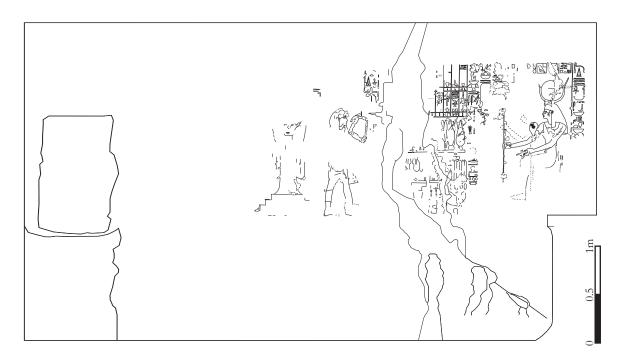
1. Line drawing of the south wall of Room2.

8.1. Line drawing of the south wall of Room 2.

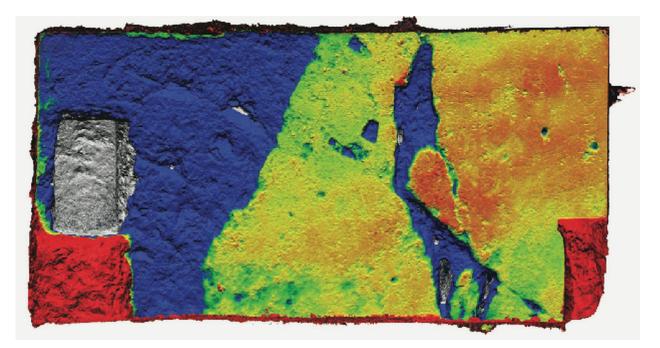
2. Photogrammetric image of the south wall of Room 2.

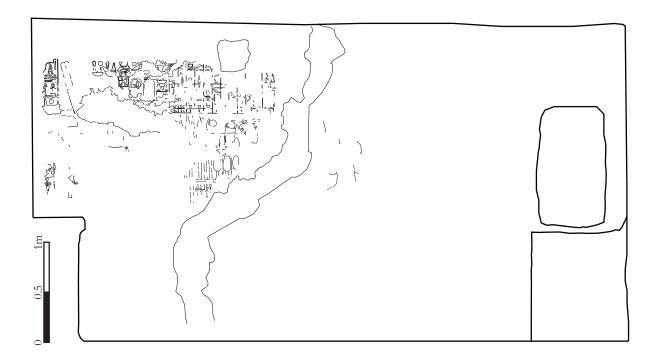
1. Line drawing of the north wall of Room2.

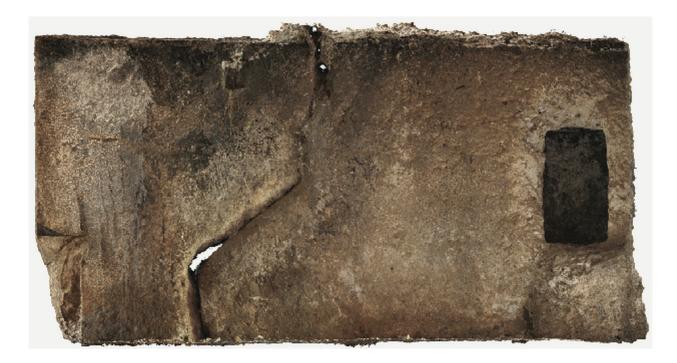
2. Photogrammetric image of the north wall of Room 2.

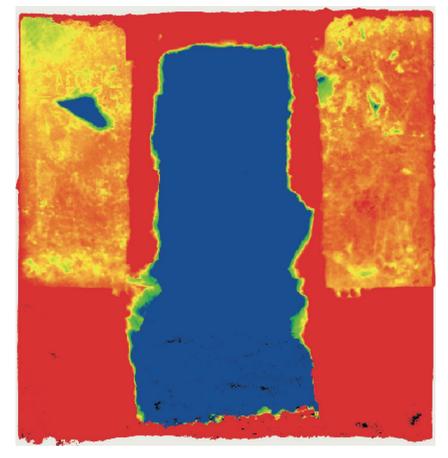
2. Photogrammetric image of the west wall of Room2.

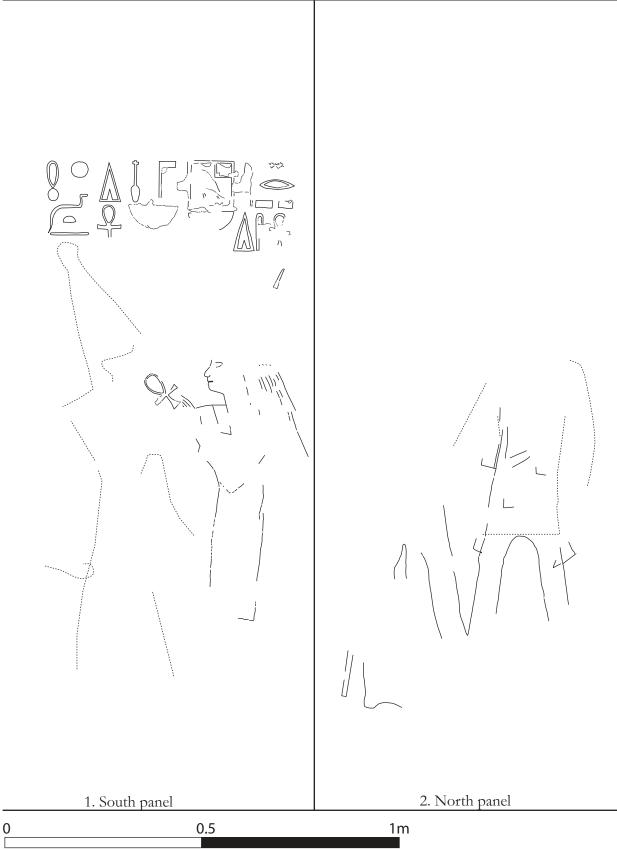
—— Tracing of outlines of figures
Features revealed by post processing

1. Decoration of the west wall.

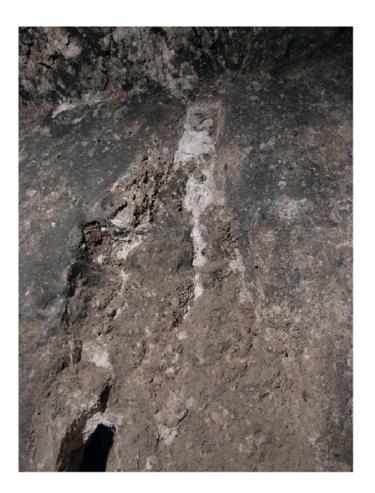
1. Plaster fill of natural crack in north wall.

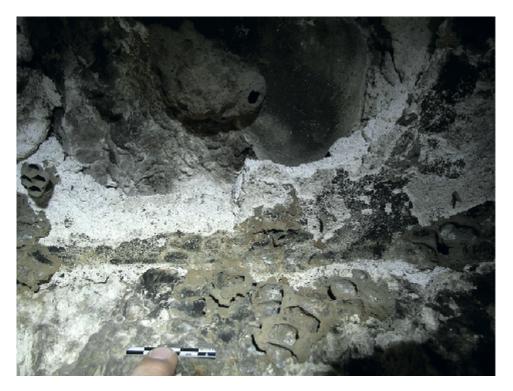
2. Layers of plaster on ceiling on the east end.

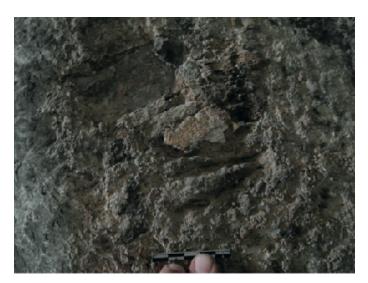
1. Yellow coloured plaster on north wall.

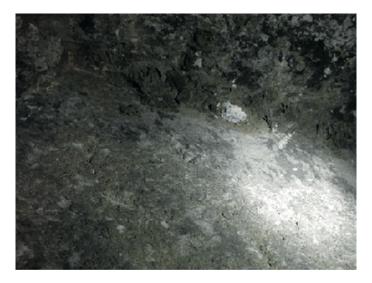
3. Sooth and wasp nests on ceiling.

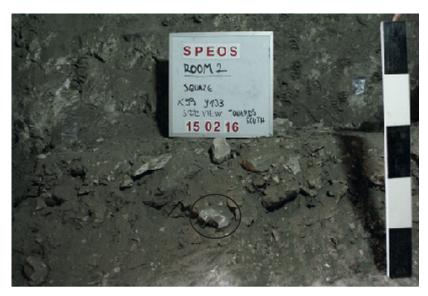
2. Profile of rubble with visible piece of plaster at its bottom.

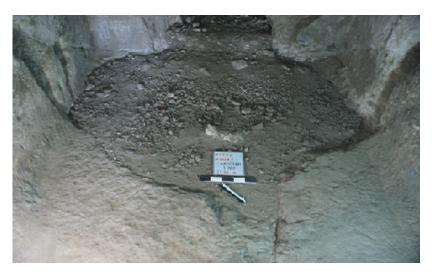
3. Modern intrusion in front of main niche.

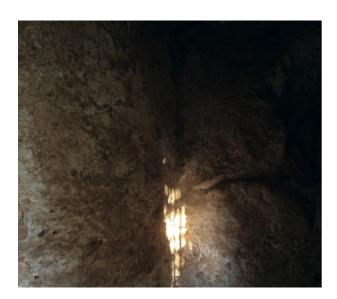
1. The access of sunlight on the north-western corner of Room 1.

- 34.1. Photo showing the access of sunlight on the north-western corner of Room 1.
- 34.2. 3D Model of speos showing the access of sunlight on the north-western corner of Room 1.
- 34.3. 3D model of speos showing access of sunlight into Room 2.
- 34.4. Photo of valley on the other side of the Nile opposite the speos.
